Roof Diagnostics Report

JULY 8 2019

Property: Century Park Condominium
Phase 1
Number of Buildings: 20
Client: Century Park Condominium Phase 1
Property Manager: Rogelio Cainzos
Phone: 3054410904
Email: rcainzos@gablesprorealty.com
Location: 8950 West Flagler Street, Miami,
FL 33174

Notes By: CMR Roof Inspector

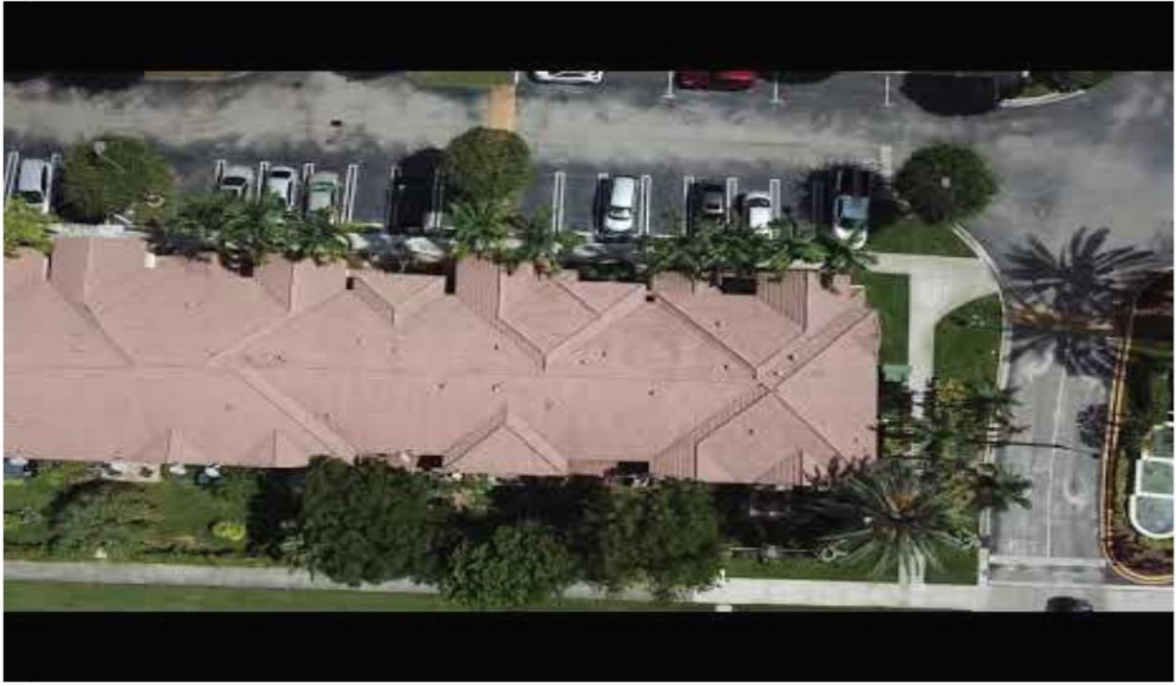
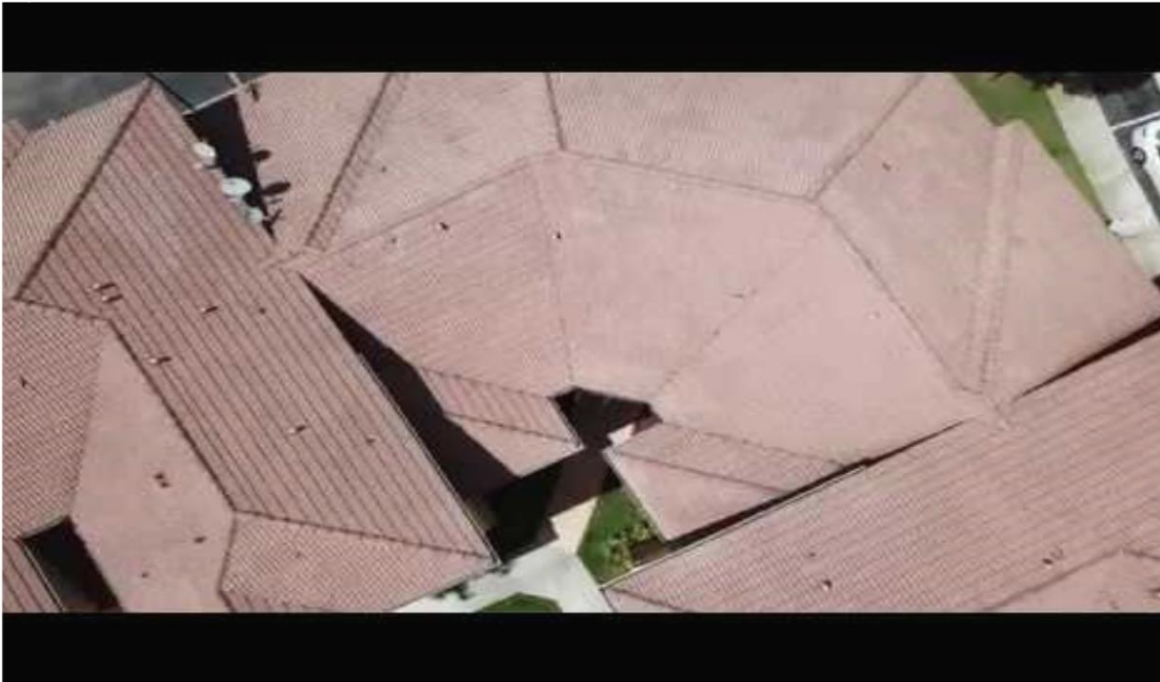
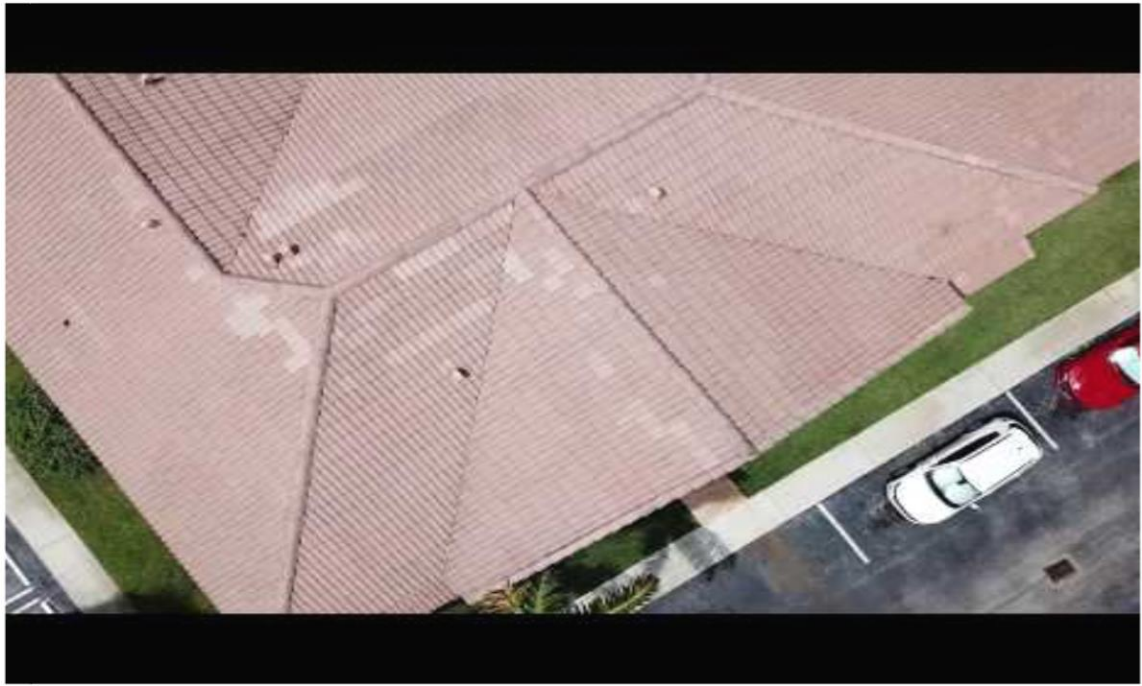
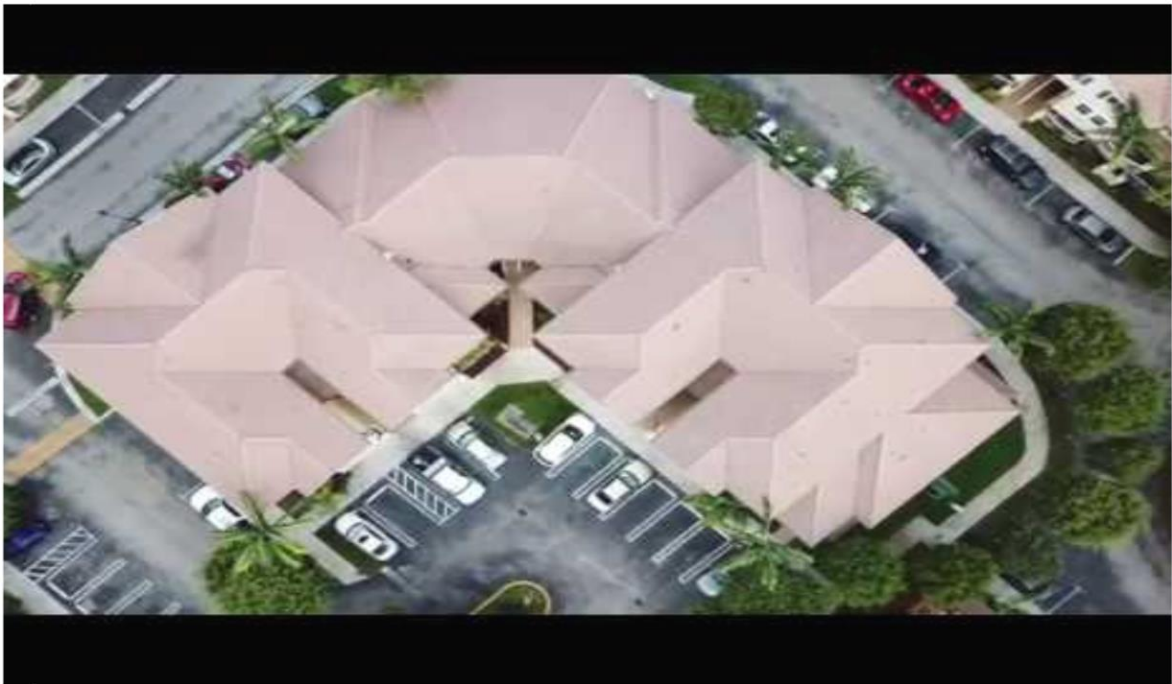
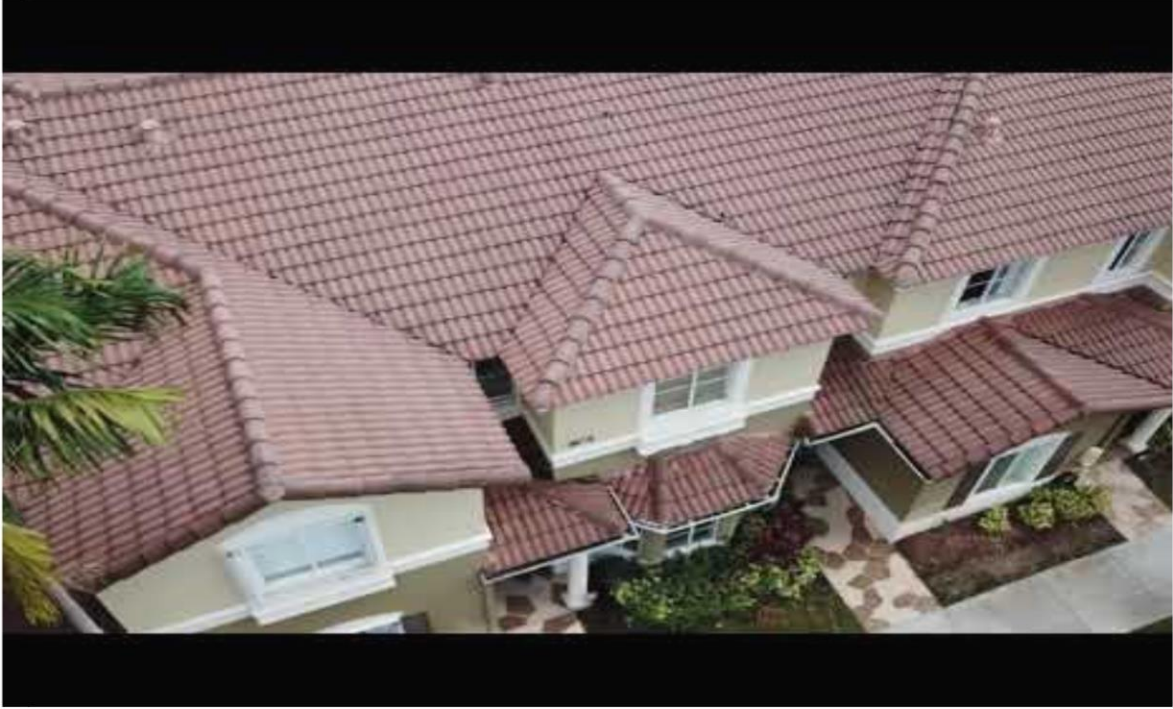
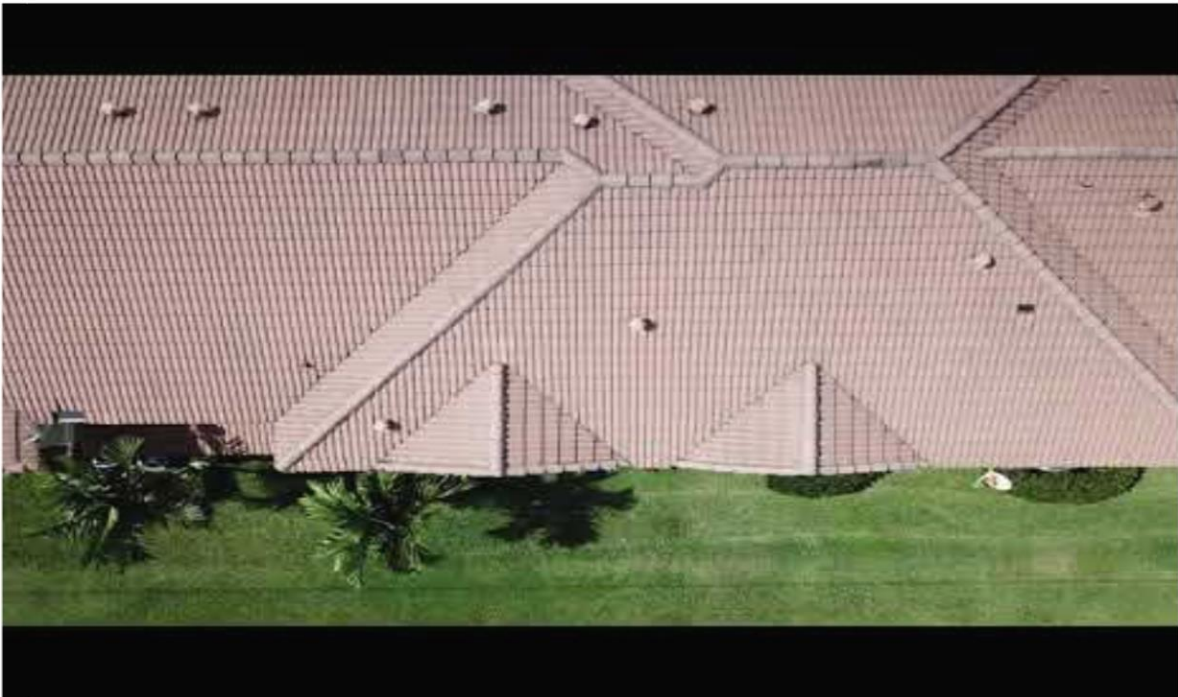
Number of Stories	2-3 Stories 20 Buildings
Age of Roof	19 years
Material of Roof	Clay or Concrete Tile
Type of Decking	Wood Deck
Type of Edge Metal	Painted Galvalume
Pitch	5/12
Drip Edge	3"x3"
Signs of Storm Damage	Missing tiles, Cracked tiles
Signs of Fascia Damage	Cracked Ridge, Damaged mortar
Signs of Internal Water Damage	Yes
Non-Roof Related Damage	N/A
Other Concerns & Comments	Wind damage was found on all buildings. Majority of the damage was found on the east and south slopes consisting of wind lifted and cracked tiles.

There are penetrations in the roofing, missing tiles, many of the ridge caps on all sides are loose, mortar is cracked, and many of the tiles are lifted more than 2 inches. The tile on the roof is discontinued and if not replaced will continue to lead to more leaks in the future. The damage seems to have been created by high winds and most likely related to hurricane Irma. We recommend replacing the roof with new tile or a more viable roofing system for the area, such as stone coated steel or a metal roof to deter this from happening again. [All images and videos not in the report are here.](#)
